CHAPTER 3:

The State of Onondaga Creek: Findings

onondaga
creek
CONCEPTUAL REVITALIZATION PLAN

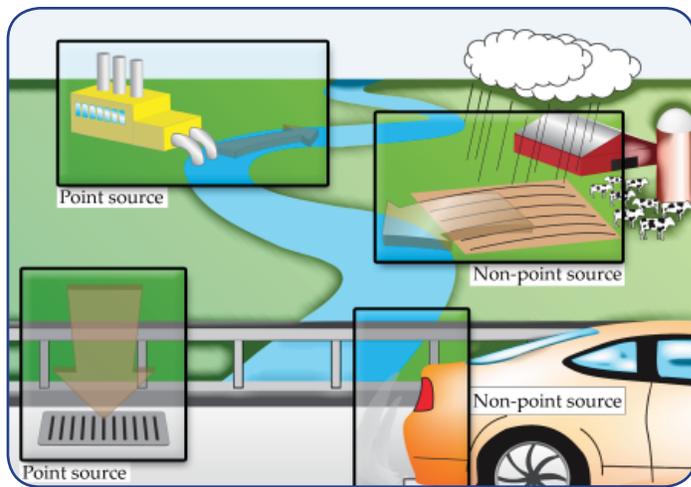
Figure 3.1 Potential sources of nonpoint and point source pollution.

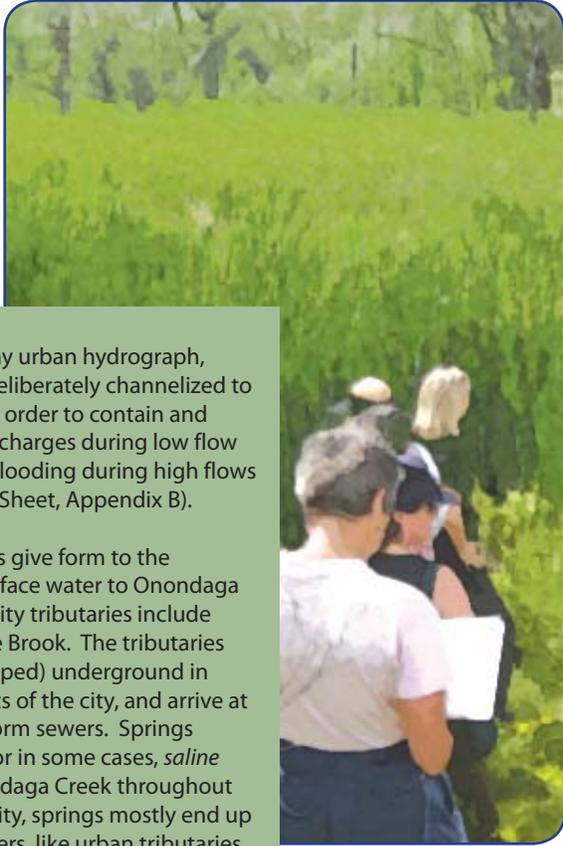
- Despite human modifications to Onondaga Creek such as channelization (artificial straightening of the creek channel), destruction of wetlands, elimination of creekside vegetation and damming, the creek still functions based on the natural hydrologic cycle. The hydrologic cycle governs the water level and flow rates in the creek, see Figure 3.2.

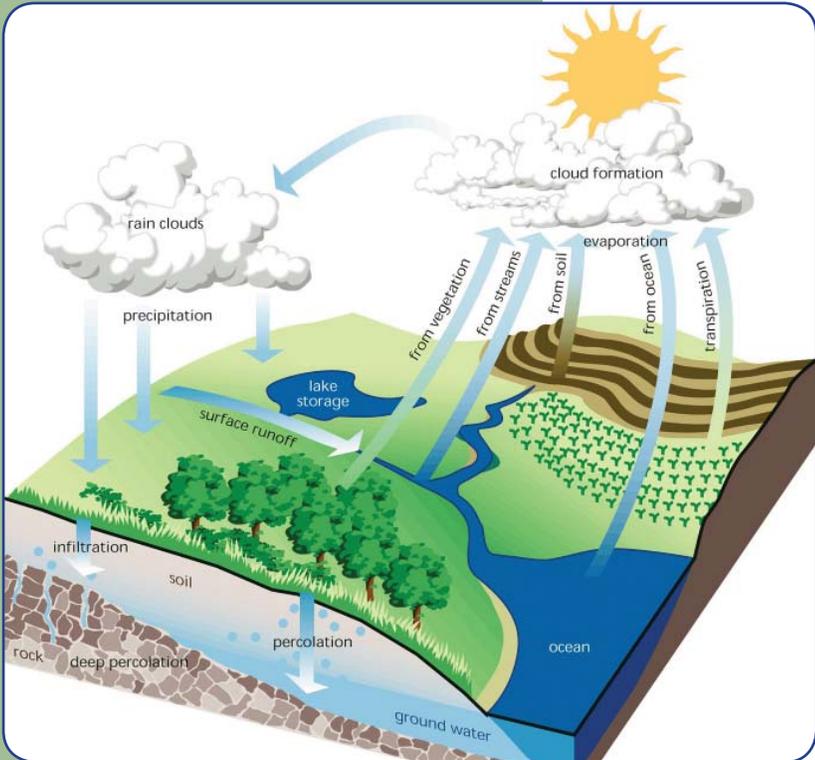
Figure 3.2 Hydrologic Cycle (FISRWG, 1998)

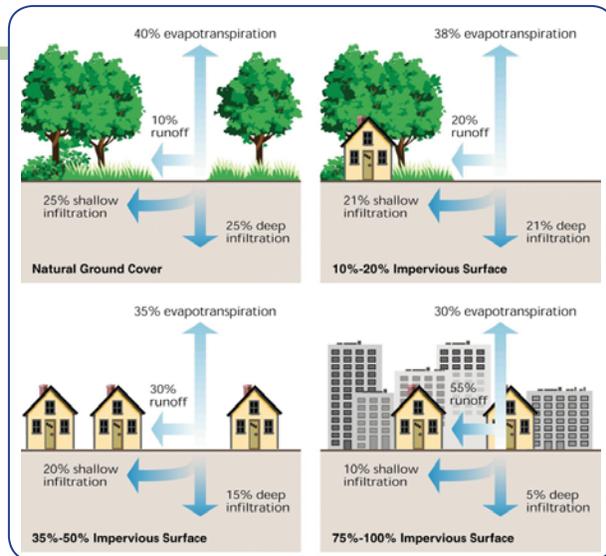
Figure 3.5 Relationship between impervious cover and surface runoff (FISRWG 1998).

- Greater concentration of residential and commercial land cover occurs in and near downtown, the northernmost portion of the creek's watershed, readily visible on the land cover map. Greater residential and commercial density correlates to greater impervious surface, see Figure 3.5. Impervious cover increases surface runoff, discussed under Hydrology. Streams can be degraded with as little as 10 percent impervious cover in the watershed (FISRWG 1998).

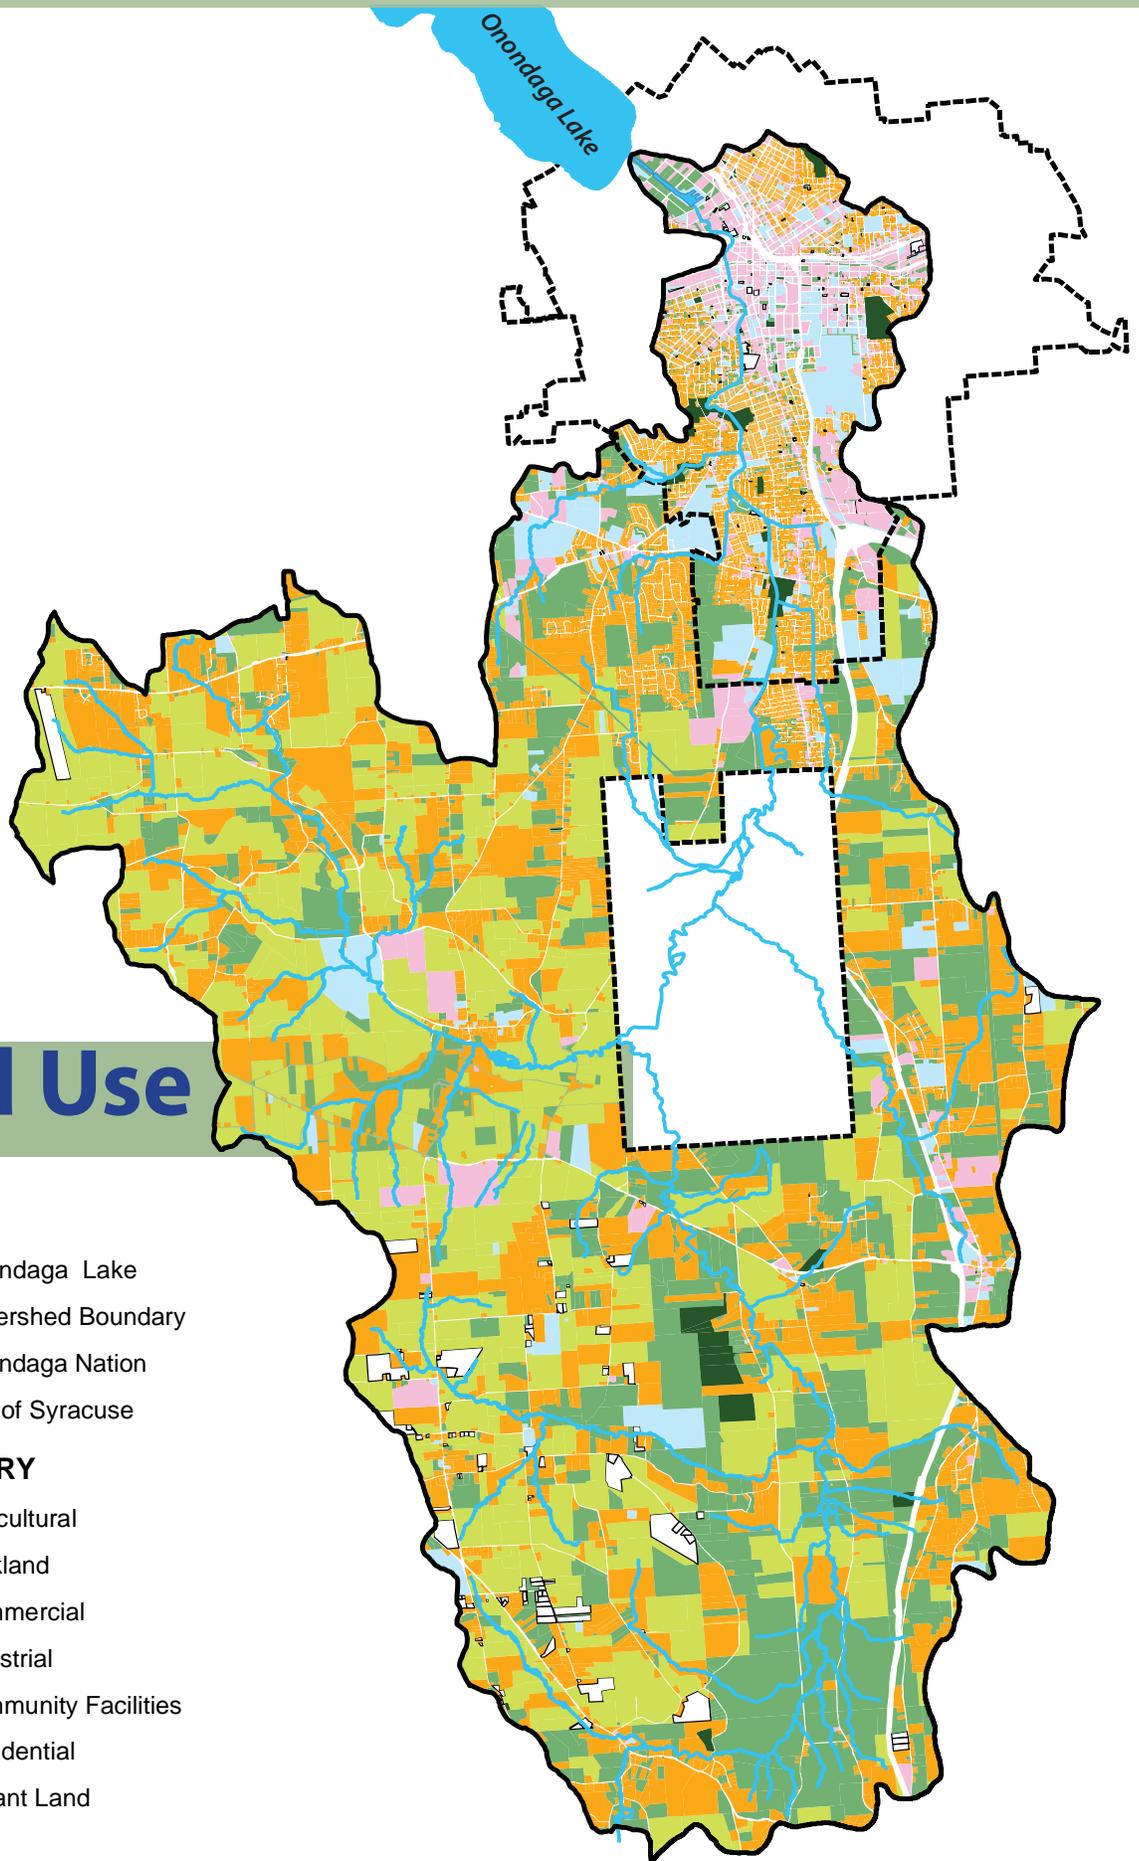
Figure 3.3

Land Use by Parcel

- The term land use describes human land use, usually related to economic activity. The term land cover describes material, either natural or human-made, on the land surface. On the following pages, two watershed maps compare land use (Figure 3.3) and land cover (Figure 3.4).

- Land uses are primarily agricultural and residential in the rural portion of the Onondaga Creek watershed, including Tully Valley and the West Branch of Onondaga Creek. Land lots tend to be larger; the average agricultural parcel size is about 40 acres, the average residential parcel ranges from two to eight acres.

- In the urban portion of the watershed, from Nedrow through Syracuse, land lots are much smaller, averaging 0.25 acres. There are two distinct types of land use in Syracuse. From its southern border to the edge of the downtown, the city is primarily residential; this is where the greatest population density exists near the creek. Downtown (the central business district, or CBD) is the center of commercial activity, with less residential use.

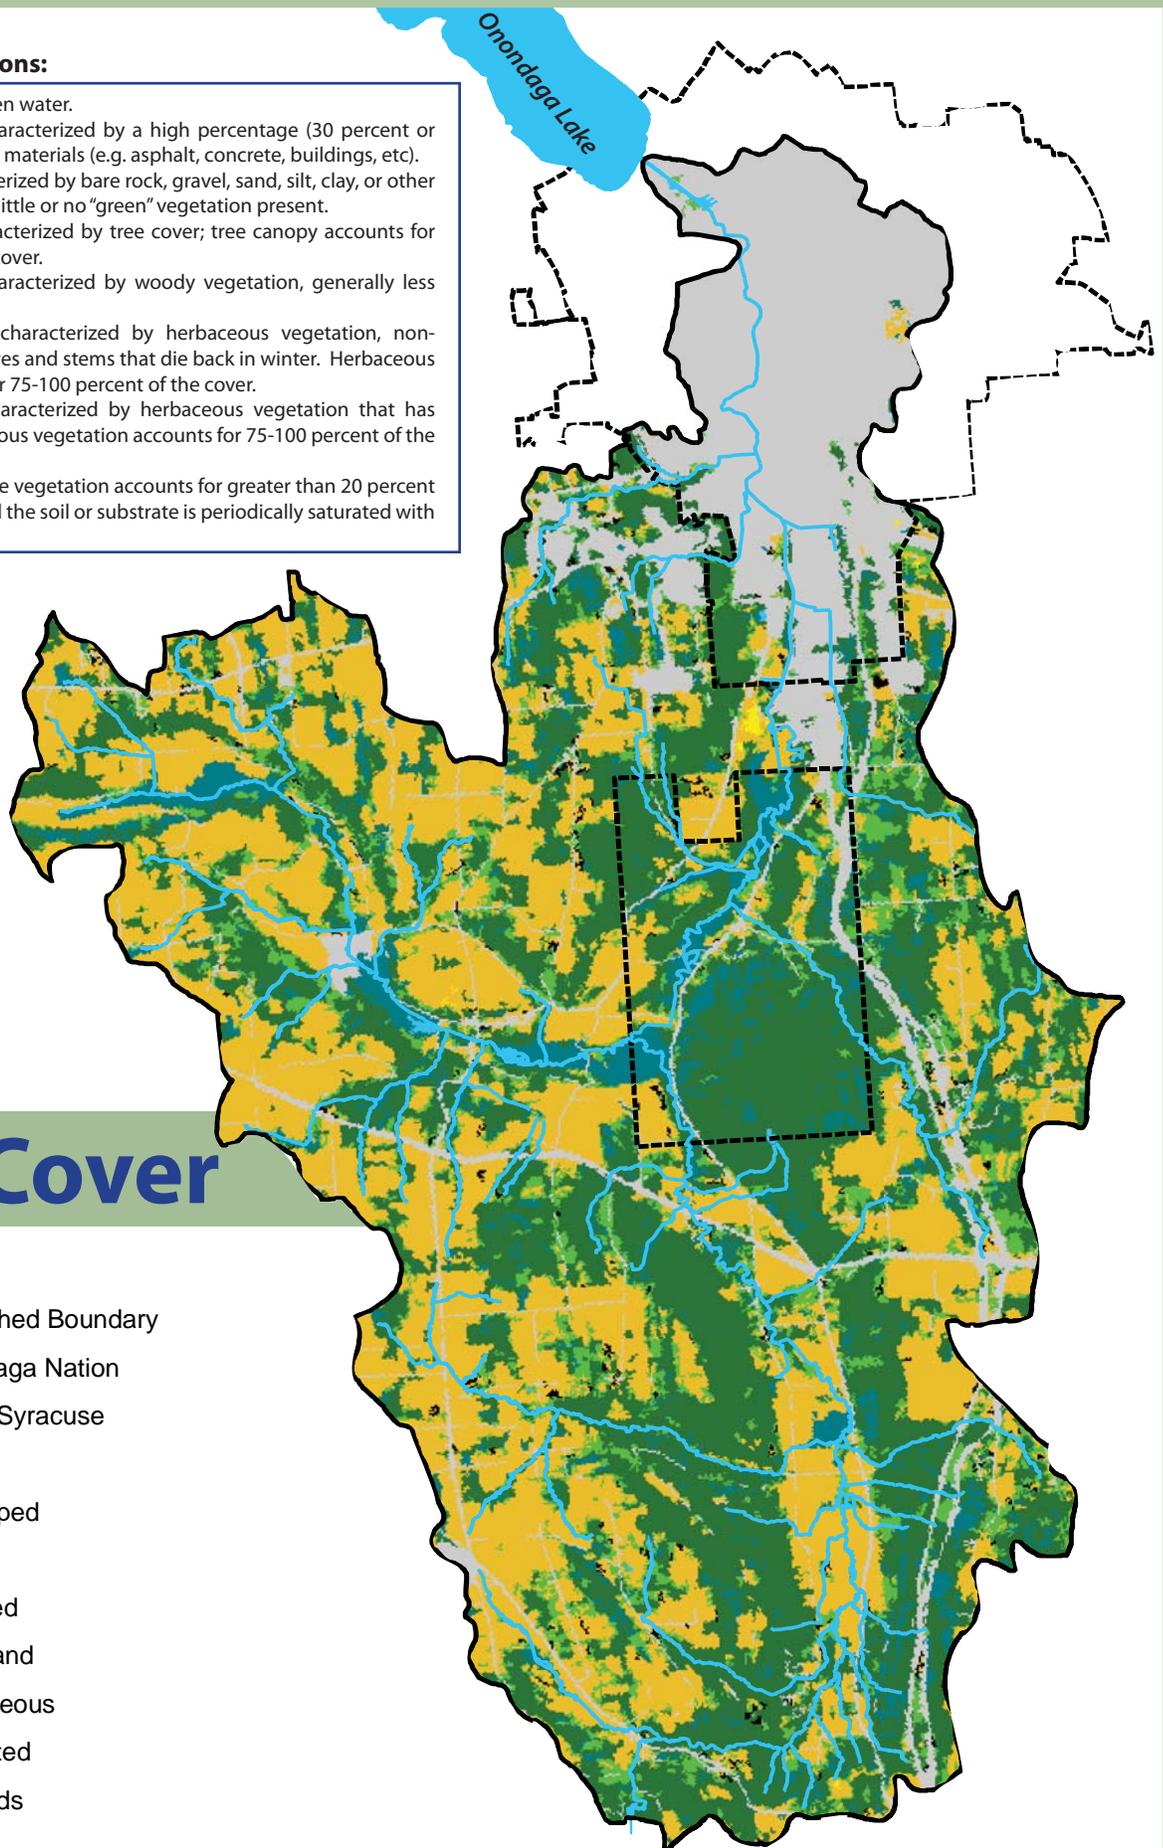
Figure 3.4

Land Cover
