# Landslides, Subsidence & Fractures Onondaga Creek Fact Sheet

## **TULLY VALLEY LANDSLIDES**

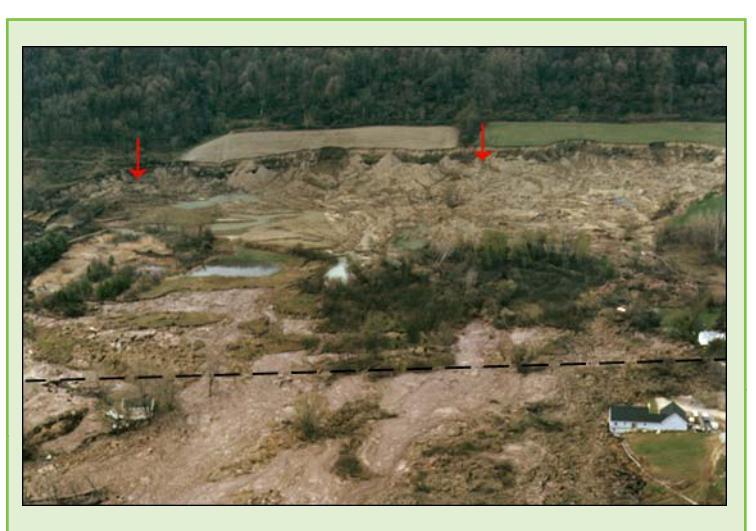
Figure 1: Oblique aerial view of the Tully valley landslide taken April 30, 1993, three days after the slide. Debris moved toward the viewer, in the process covering Tully Farms Road (dashed line) with up to fifteen feet of reddish remolded clay. Three people were rescued by helicpoter behind the white house (lower left) from the rapidly advancing landslide. Springs are located between the red arrows. source: http://pubs.usgs.gov/fs/fs13-98

**Land slumping** on a valley wall occurred at the foot of Bare Mountain on April 27, 1993, when 1.3 million cubic yards of land slid across Tully Farms Road towards Onondaga Creek. (Fig.1) Research by the US Geological Survey (USGS) of other sites along the foot of Bare Mountain found evidence of previous landslide occurrences that ranged from 7,000 to 10,000 years ago.

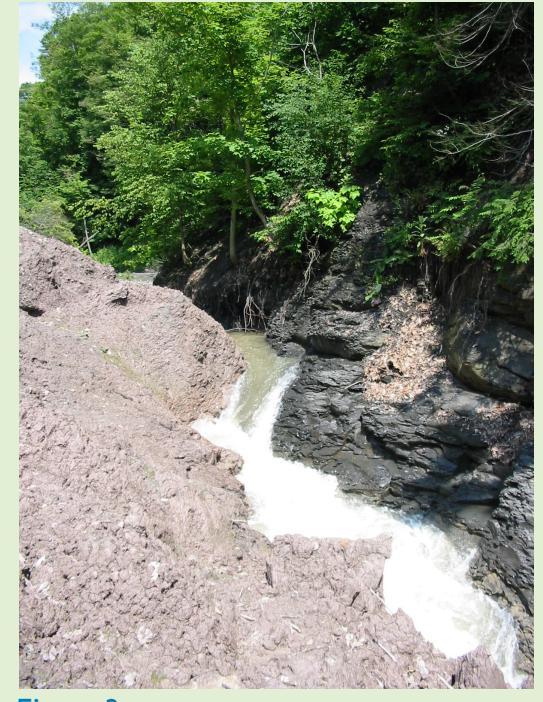
Figure 3 Source: USGS photo of Rattlesnake Gulf, Tully Valley, New York

landslides along Rattlesnake Gulf are attributed either to bedrock failure or sediment-slope failure, both related to stream toe-cutting. (Fig. 3)

**Stream toe-cutting into glacial sediments along Rattlesnake Gulf.** Ongoing landsliding in Rattlesnake Gulf has also cut away at the base of a massive bluff consisting of clay soil on the south side of this steep stream channel. The face of the bluff continues to slide into the stream, further exposing the bluff to rapid erosion and partly blocking the channel under the bridge at Tully Farms Road and also adding turbidity to Onondaga Creek. This landslide area was apparently active before the late 1930s (when the first aerial photography of the region was collected) and continues to erode into the steep hillside today (2008). Previous

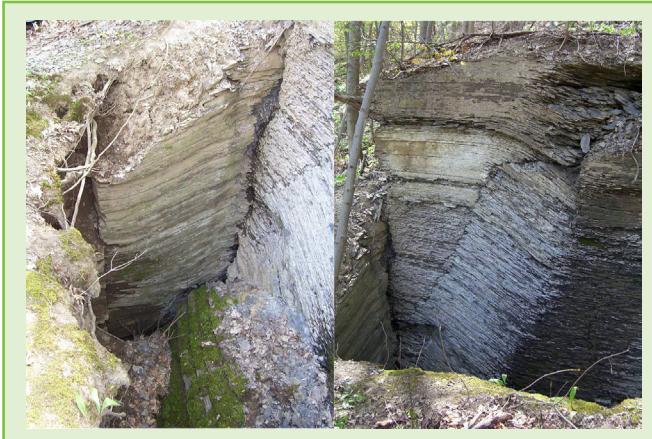
#### **Figure 5a** Source: USGS William Kappel presentation to US EPA April 7, 2008, slide 33

**Subsidence** of the land surface in the former brine fields is visible on the east and west sides of the valley floor, above the subsurface rock-collapse zones (Figure 5a, sinkhole). The subsidence extends across the valley floor between the east and west brine fields (Fig.5b, map).

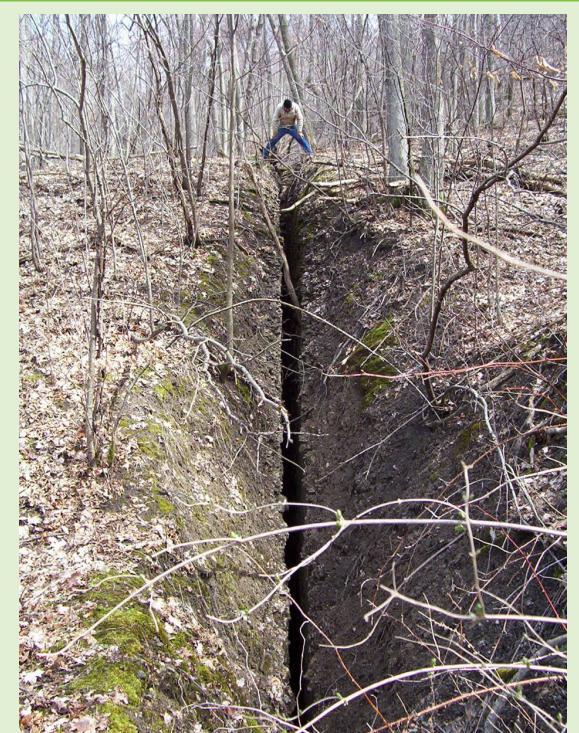
Figure 6

**Multiple new bedrock fractures** have opened along these joint surfaces in the east and west valley walls (Fig. 6), upslope of the brine field subsidence. These fissures have opened at a rate which can be identified by tree roots that straddle a fissure (Fig. 7). Hydraulic connections may have developed within these 'enhanced' fracture zones and the unconsolidated mudboil aquifer.
